A Tale of Two Fountains

by David T. Ford and Fatemeh Shirmohammadi

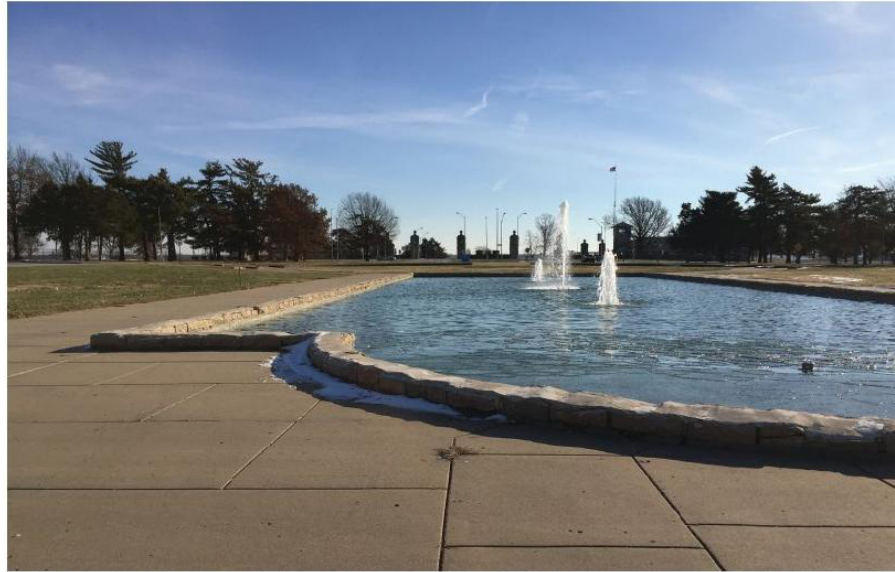
Fig. 1: Delbert J Haff Circle Fountain before renovation

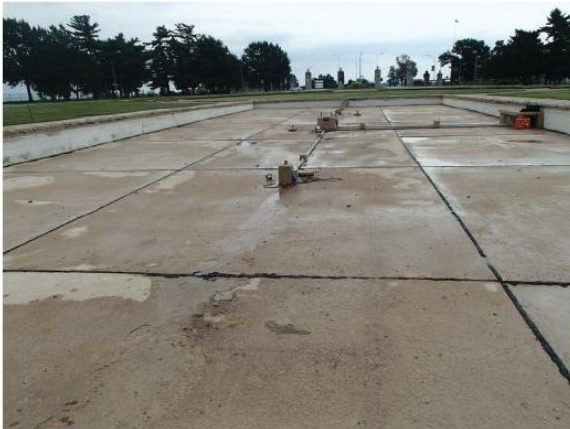
Aside from periodic maintenance, the fountain pool never underwent significant renovation or improvement over the years. By the 2010s, the concrete structure was crumbling with numerous cracks and spalls. The original concrete floor (Fig. 2 and 3) and walls (Fig. 4) showed numerous locations of concrete distress and the original filler in the concrete basin joints or wall-to-floor transition joints had not been replaced during its lengthy service life. Significant deterioration was observed at various locations within the perimeter architectural capstones. The original limestone masonry capstone on top of the basin walls was installed flat and the lack of slope had allowed rain and snow to collect on the stones, damaging the masonry substantially over time.

Next, three concrete cores were extracted from the fountain's basin. While the compressive strength and chloride content of the cores were favorable, the quality of the internal microstructure—internal cracking caused due to past freeze-thaw—had and would continue to damage the concrete.

Fig. 2: Concrete spalling at fountain slab

Considering the condition of the basin slab and walls, the original slab-on-grade needed to be removed while the concrete walls of the fountain could be salvaged. A 6 in (150 mm) thick, heavily reinforced concrete slab-on-grade was designed with water stops and expansion/control joints to limit cracking (Fig. 5). To further ensure water-tightness, a two-coat, cementitious waterproofing system was applied to the new basin slab and original fountain walls, which were sounded and partially repaired as needed. The new, cementitious waterproofing system also created a protective layer to expand the service life of the concrete slab. To finish, the design added a new dolomite capstone with a sloped surface on top of the

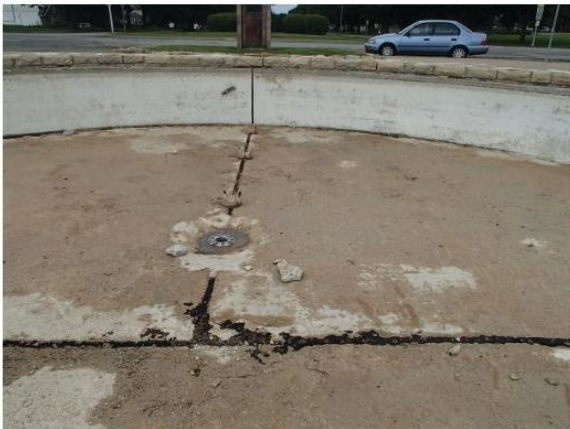
Fig. 3: Close-up of concrete spalling at fountain slab

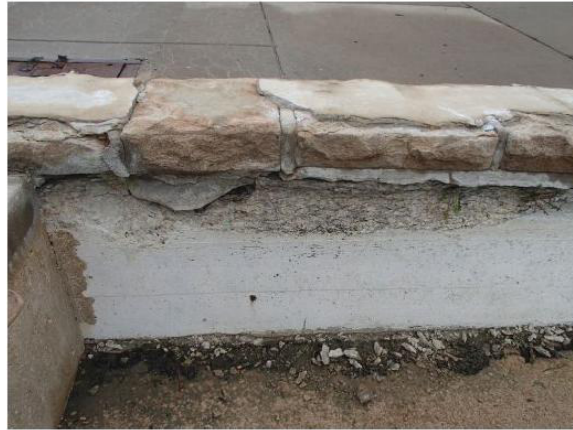
Fig. 4: Concrete deterioration at original concrete walls

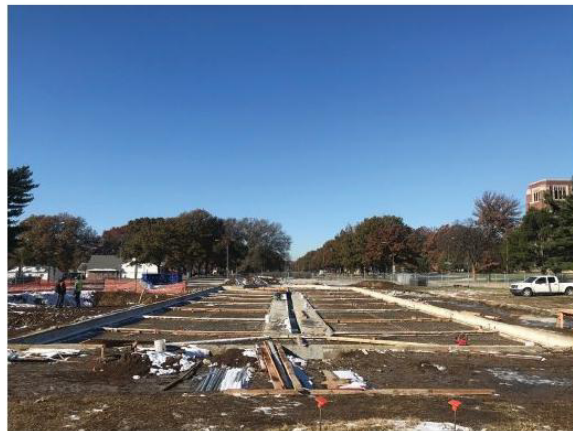
Fig. 5: Construction of new slab-on-grade

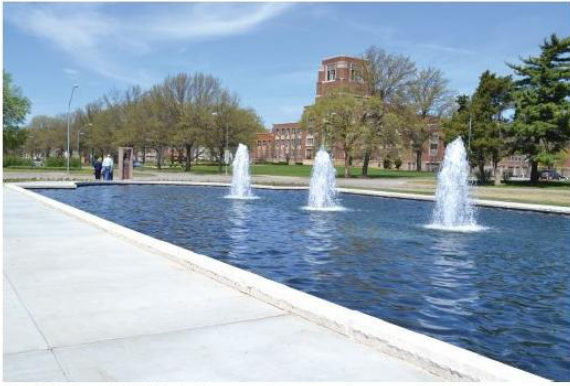
Fig. 6: Delbert J. Haff Circle Fountain after renovation

original walls. In the end, the fountain's volume was cut in half—from 223,000 gallons (844,150 liters) to 111,500 gallons (422,075 liters)—and created a more sustainable water feature that retains all of its original beauty (Fig. 6).

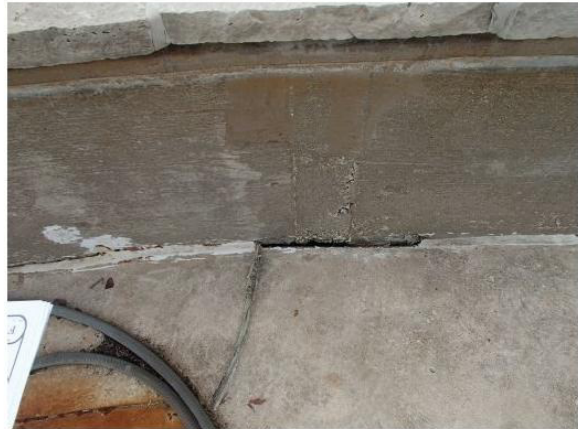
Fig. 8: Gap between basin floor and perimeter wall

To identify the source of water leakage in the vault, members of KC Parks' facility maintenance management team were interviewed. They indicated that the vault didn't flood when the fountain was empty, and thus, partially attributed the source of leaking to deficiencies below the central pedestal. After water-spray testing the pedestal and other locations of the basin, the source of the leak was identified at the joint between the basin floor and the perimeter walls on the south side (Fig. 8). To remedy this issue, sealing the joint and adding a cementitious waterproofing system on the top was recommended.

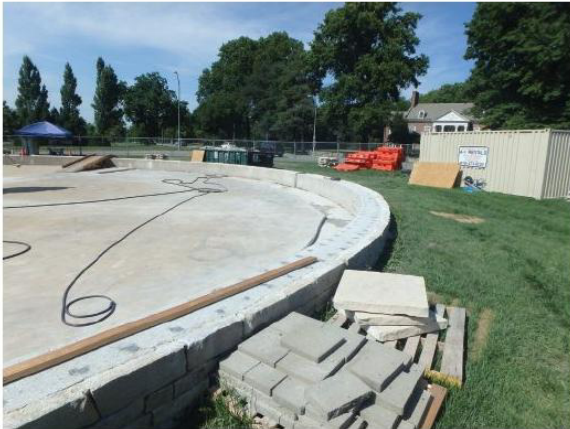
Fig. 9: Creating slope at top of perimeter wall using concrete overlay

To finish, the existing capstones on top of the basin walls were installed flat. Because the existing capstone was in fair condition—unlike that of the Haff Fountain—the adjustment could be done on top of the wall. The existing capstones were removed and re-installed after creating a slope on top of the wall using a concrete overlay (Fig. 9). To support maintenance efforts, a new subgrade concrete vault was designed to house upgraded mechanical and electrical equipment, replacing the existing fiberglass vault (Fig. 10). Views of the fountain after renovation are shown in Figures 11 and 12.

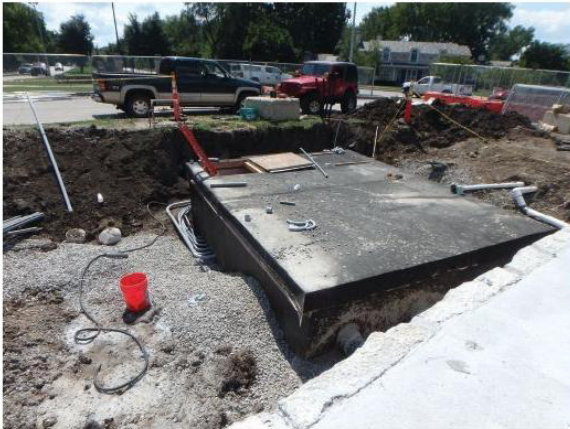
Fig. 10: Installing new underground concrete vault

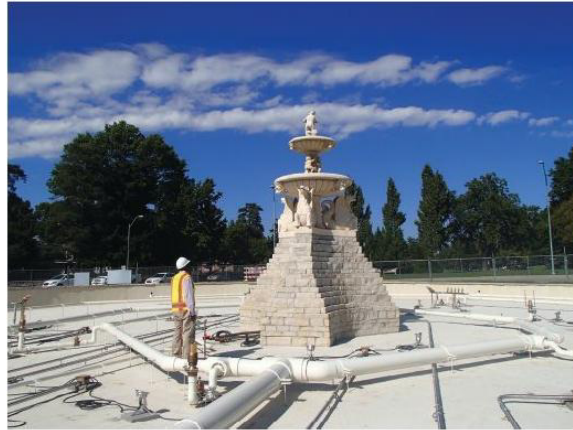
Fig. 11: Meyer Circle Sea Horse Fountain after renovation

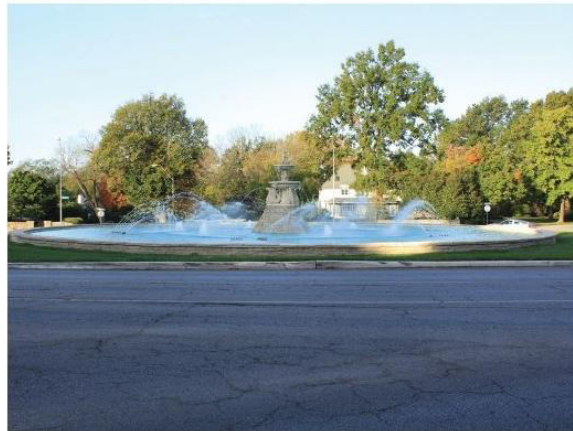
Fig. 12: Meyer Circle Sea Horse Fountain in operation after renovation
