A Tale of Two Fountains

by David T. Ford and Fatemeh Shirmohammadi

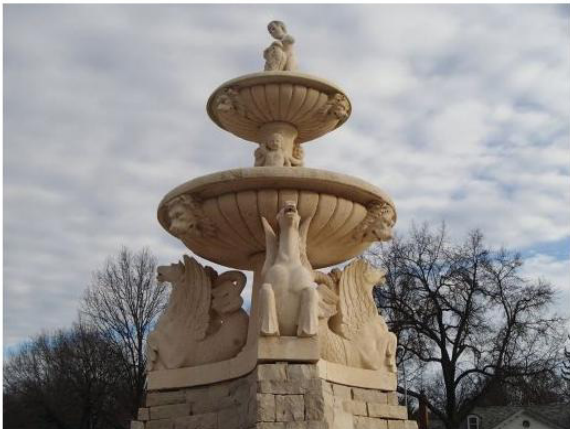
Fig. 7: Sculpture at center of Meyer Circle Sea Horse Fountain

landmark. The ornamental sculpture resting on top of the masonry pedestal traces its roots to 17th Century Italy (Fig. 7). It was purchased by J. C. Nichols in Venice in the early 1920s and gives the fountain its whimsical name, with the three mythological sea horses perched atop the stone pyramid.
